MONHEGAN ISLAND WHARF

PRELIMINARY DESIGN REPORT

**MONHEGAN ISLAND WHARF**

JULY 1988

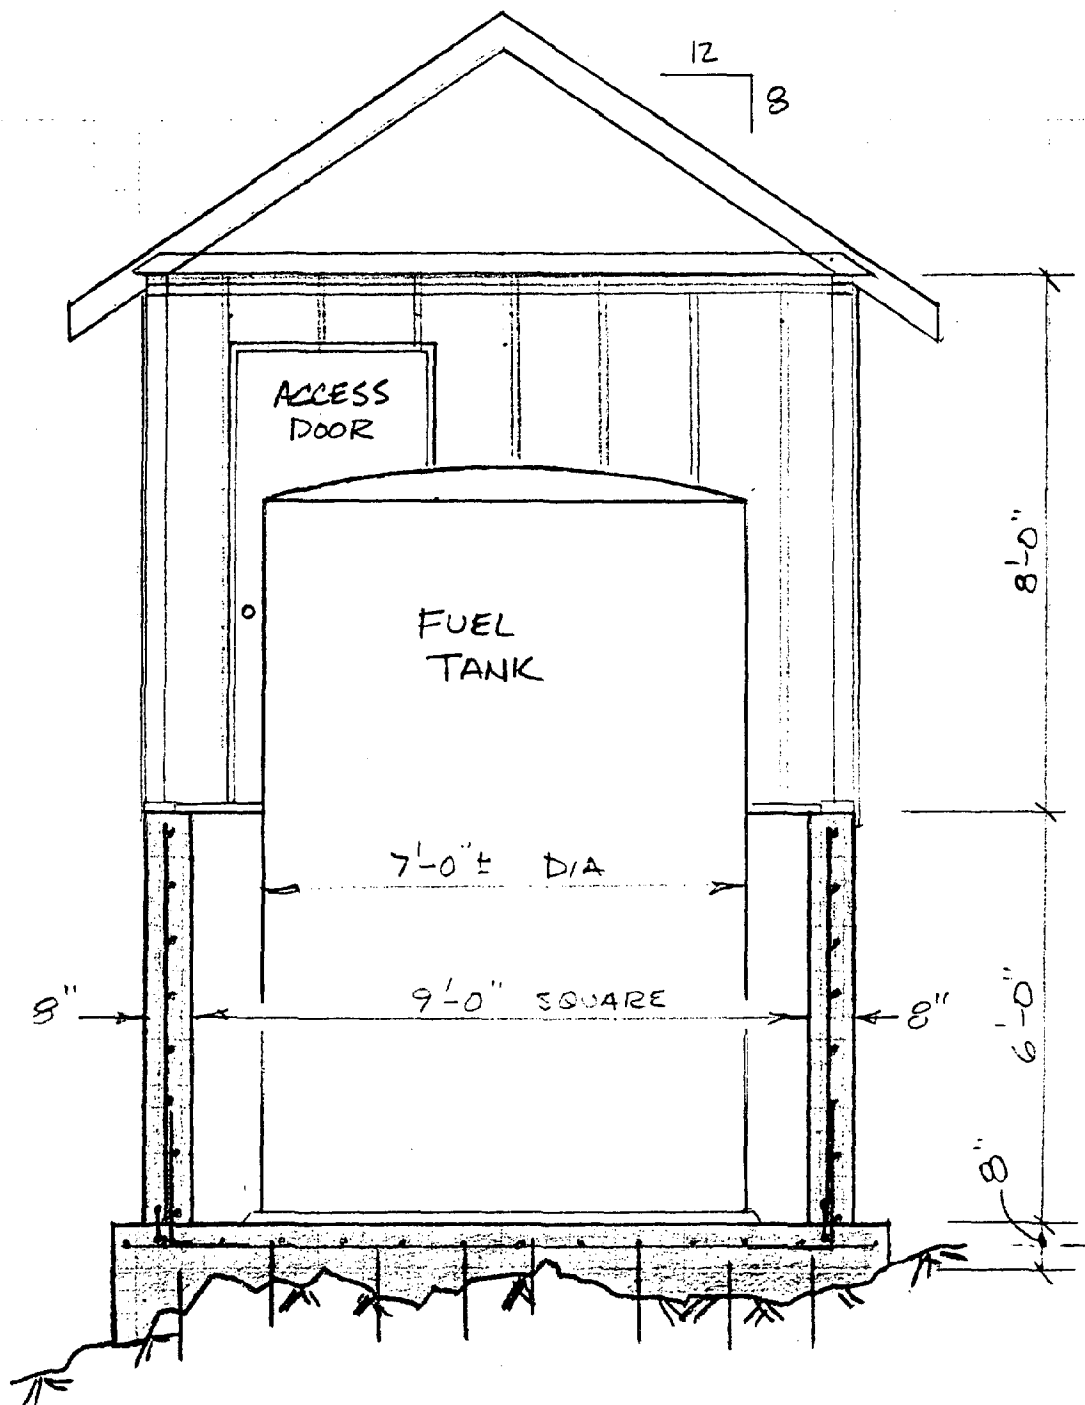
# SPILL CONTAINMENT STRUCTURE

Two cylindrical steel fuel tanks occupy the southeast face of the wharf surface (see Figures 14 & 15) adjacent to the freight shed. The easterly tank rests on a concrete pad and holds approximately 3,000 gallons. The westerly tank rests on a wood frame and holds approximately 2,500 gallons. Neither tank is positively held down to prevent movement or overturning due to earthquake, wind, or wave impact. In addition, no provision currently exists to contain a spill should one occur due to tank leakage. Figure 8 describes a proposed solution which would contain the full contents of the tank if a spill should occur and also keep precipitation out of the containment area.

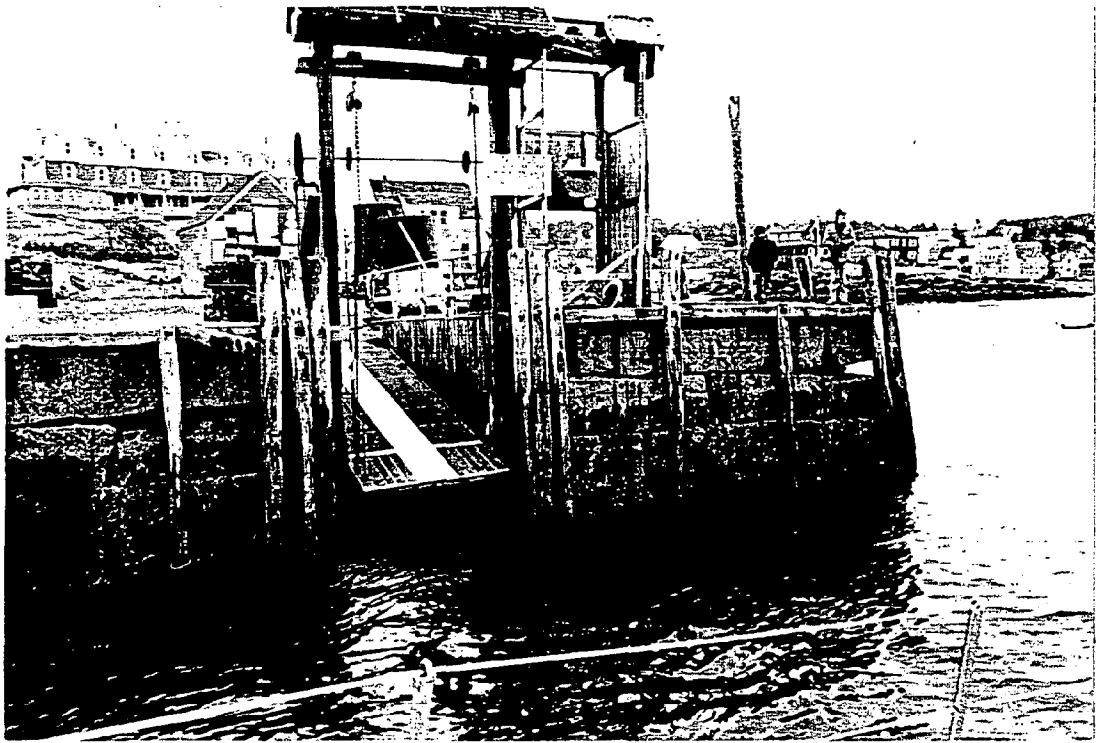
Wharf slip

The wharf slip (see Figure 2) or loading/unloading ramp is a 7'x30' aluminum platform hinged on the east end and supported on the west end by cables attached to a counter weight and to chain falls. The chain falls are operated by a manually powered pulley and chain mechanism connected to a continuous loop pull chain (see Figures 12 & 13 for photographs.) The counterweight, chain falls and operating mechanism are supported by a timber frame. The operating mechanism requires considerable effort to raise the ramp as it is worn and frequently slips and jams. Chain falls are not designed to be reliable enough to support structures carrying people. Although no problems have been reported, other lifting methods would be more desirable. The timber frame has considerable dry rot. We recommend replacement of the entire wharf slip operating system, including supporting framework.

The system recommended by this report is similar to the system currently in place at Monhegan Wharf and at the Rockland ferry terminal (see Figures 6 & 7) and is shown conceptually on Figure 5. A steel frame supports a counterweight, connected to the end of the ramp via a spreader bar and cables and supports two cable drums on a common shaft playing out cables connected to the ramp. The common shaft is driven by worm gear right angle reducer powered by both an electric motor and another shaft connected to a hand wheel. Manual operation would be possible only after disabling the motor and conversely, power operation would be possible only after disengaging the hand wheel. Advantages of this system are the ability to operate the slip both manually and with power, the system is a proven, widely used approach, and relative economy.

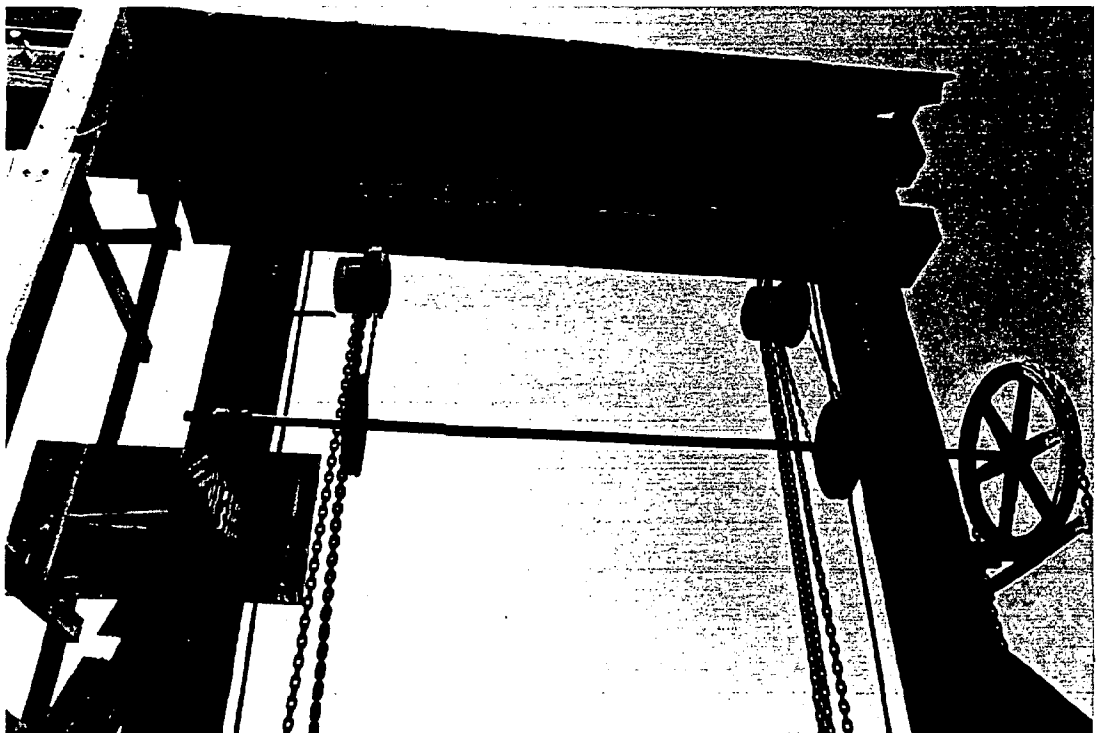
Ramp lifting mechanism

The timber frame supported hoisting mechanism which raises and lowers the loading/unloading ramp to adjust it to tide level is old and worn. The timber frame is decayed and needs replacement. The ramp structure itself is less than five years old of aluminum construction and in good condition.

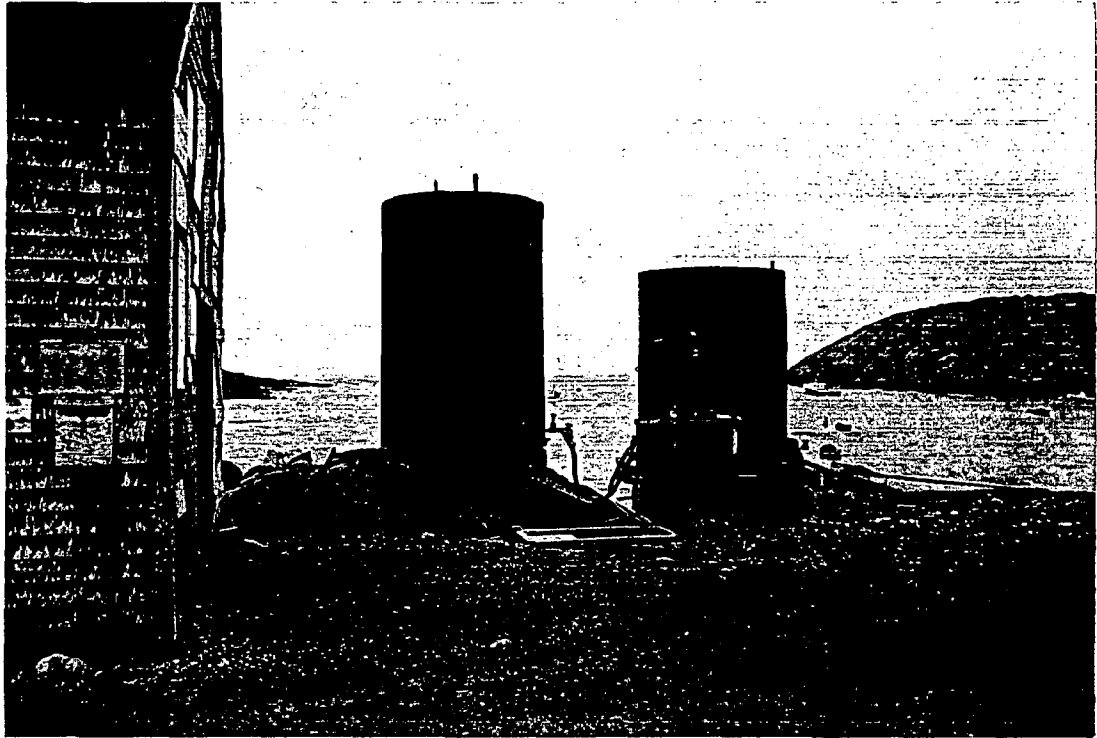
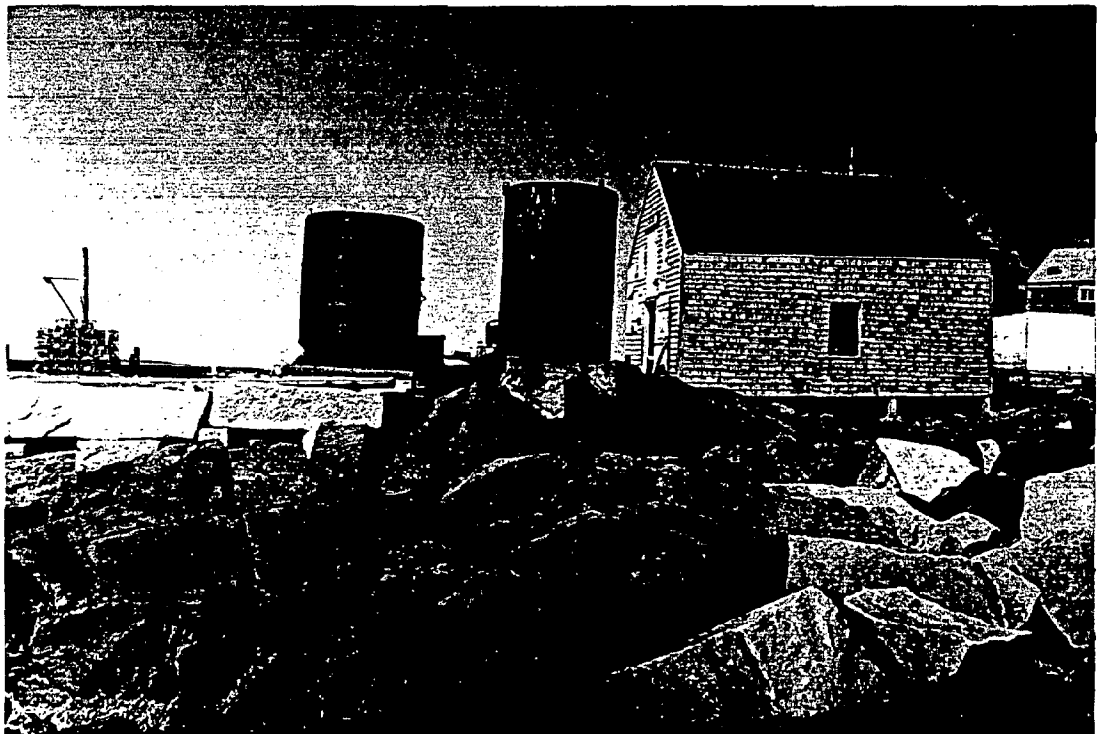
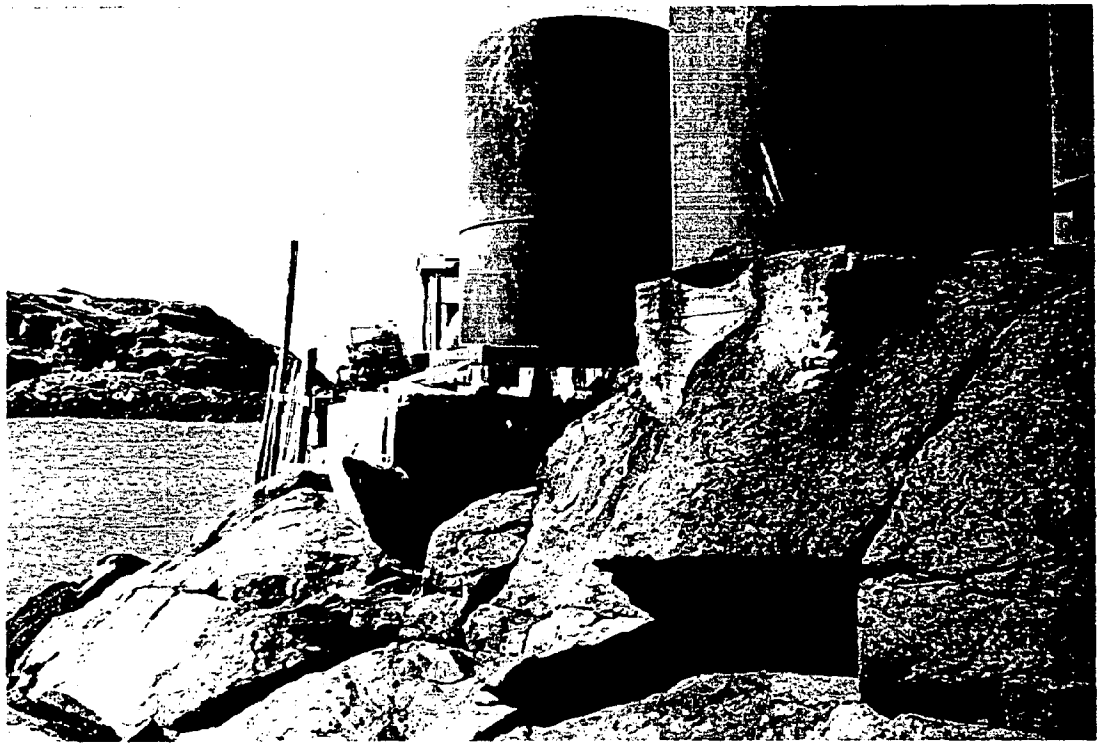
Fuel tanks looking South

Fuel tanks looking North

Fuel tanks looking West
